Rehabilitation Incorporates Con^{mic}Shield[®] to Indefinitely Extend Life of Maline Structure in St. Louis

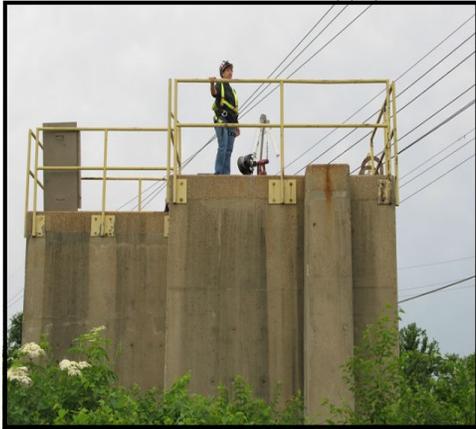
The Maline Drop Shaft located near the Chain of Rocks Bridge is just like concrete sewer structures everywhere. They corrode when hydrogen sulfide gas is present. Moderately-high temperatures, long retention times, high biological oxygen demand (BOD) levels, and turbulence contribute to elevated levels of hydrogen sulfide gas which, in turn, provide the food for acid-producing bacteria. The technical name for this process is **Microbiologically Induced Corrosion (MIC)**. This 40-year-old concrete structure was severely deteriorated from MIC. The upper portion of the walls were mushy with more than two inches of the original wall missing; in the lower half of this 50-foot-deep structure, more than five inches of the walls had corroded away.

Eight years ago, St. Louis MSD chose Specialty Sewer Company, now ADS Environmental Services, a licensed Permacast[®] applicator in the St. Louis area, to provide the quickest and most cost-effective method to restore the structural integrity of this severely-corroded structure and to prevent future corrosion. Specialty Sewer Company partnered with Spray-Com, another licensed Permacast[®] applicator with extensive experience in deep structures, on the project. A crew of five worked for 32 days and did the following to restore the structure:

- Power washed the walls back to solid material
- Stapled wire mesh to the walls for structural reinforcement of the worst areas
- Applied MS-10,000, a cementitious grout fortified with Con^{mic}Shield, in one inch lifts
- Troweled the surface after each layer was applied to ensure a densely-compacted, uniform finish
- Troweled smooth a final one-inch layer once the entire wall was rebuilt to the plumb line
